# SERVICE POINTER

L8178536  
SEPTEMBER 2005

## WHIRLPOOL FRONT LOADING WASHER

### LEAKING IN BULKY CYCLE

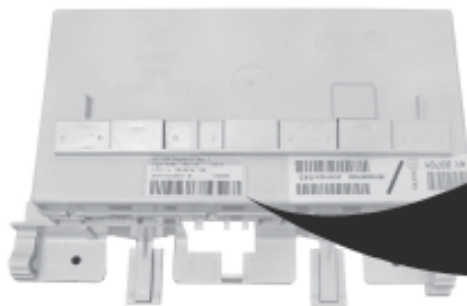
FIGURE 1

When using the Bulky Cycle, the washer could overflow, causing water to leak from the door seal.

The washer control software allows a higher water level during the bulky cycle. When the consumer washes a small load, the washer can over fill causing leakage from the door seal.

Check the door seal and verify the seal is seated properly. If the seal is OK, replace the Central Control Unit with a control that has the updated software. The number printed on the control housing label will identify the software version. The updated software version will end in a number "2", instead of a number "1". See figures 1 and 2.
