SERVICE POINTER

L8178694A
October 2007

WHIRLPOOL CABRIO AND MAYTAG BRAVOS WASHERS

CLOTHING TANGLING AND BALLING

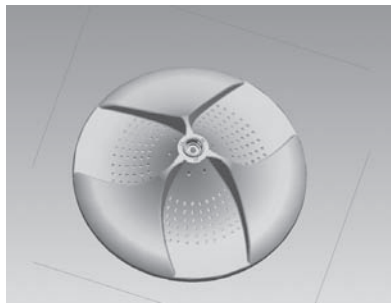
Old Impeller

Clothing in the washer can become tangled and twisted or balled up.

Under certain conditions, a combination of the wash load, the cycle selected and the subsequent load movement can cause the load to become tangled or twisted.

The wash impeller has been redesigned to make the wash load less likely to tangle under the conditions mentioned above. Replace the wash impeller with part #W10141017.

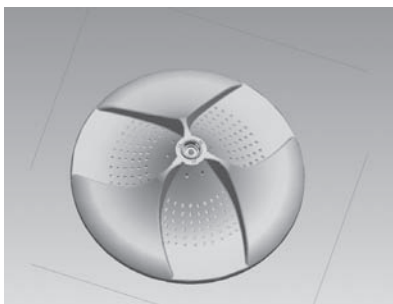
Impulsor anterior

La ropa en la lavadora se puede enredar y retorcer o hacerse un ovillo.

Bajo ciertas condiciones, una combinación de la carga de lavado, el ciclo seleccionado y el movimiento posterior de la carga pueden causar que la carga se enrede o retuerza.

El impulsor de lavado ha sido rediseñado para que sea menos probable que la carga se enrede bajo las condiciones mencionadas arriba. Reemplace el impulsor de lavado con la pieza N° W10141017.
